Function and Use of a Nineteenth-Century Barn
"Walnut Hill" Estate
Pawling Road, Lower Providence Township
Montgomery County, Pennsylvania

A THESIS
in
The Graduate Program in Historic Preservation

MASTER OF SCIENCE
1991

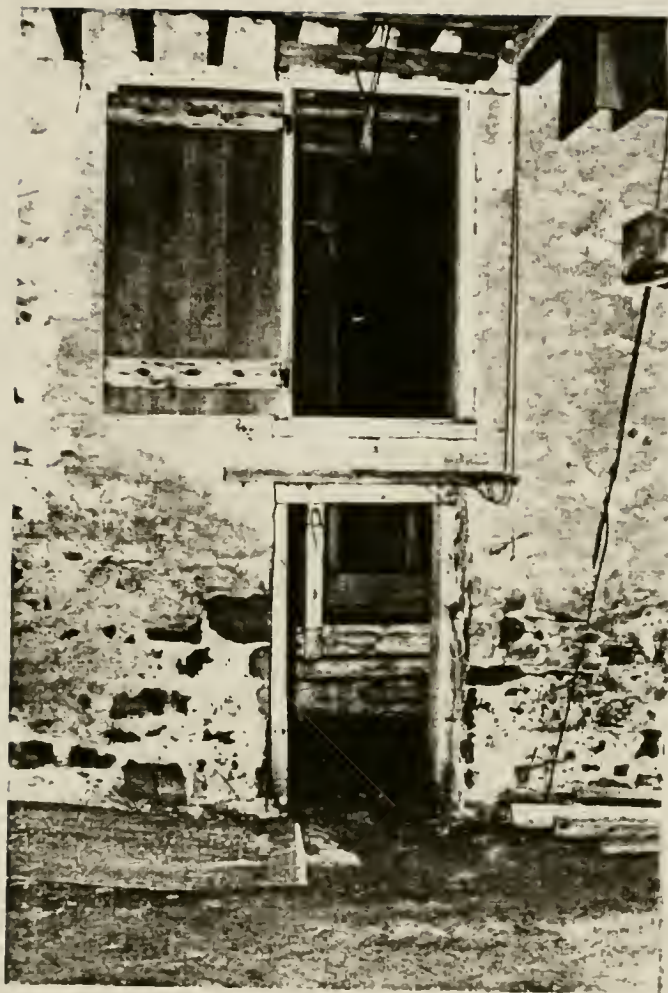
Plate 56: North elevation in carriageway of 1845 section, showing door into stables and door above to granary. Staircase along north wall of stall area provided access to upper levels. Note pieces attached to ceiling joists of barn bridge; location of machinery shown in Plate 57.

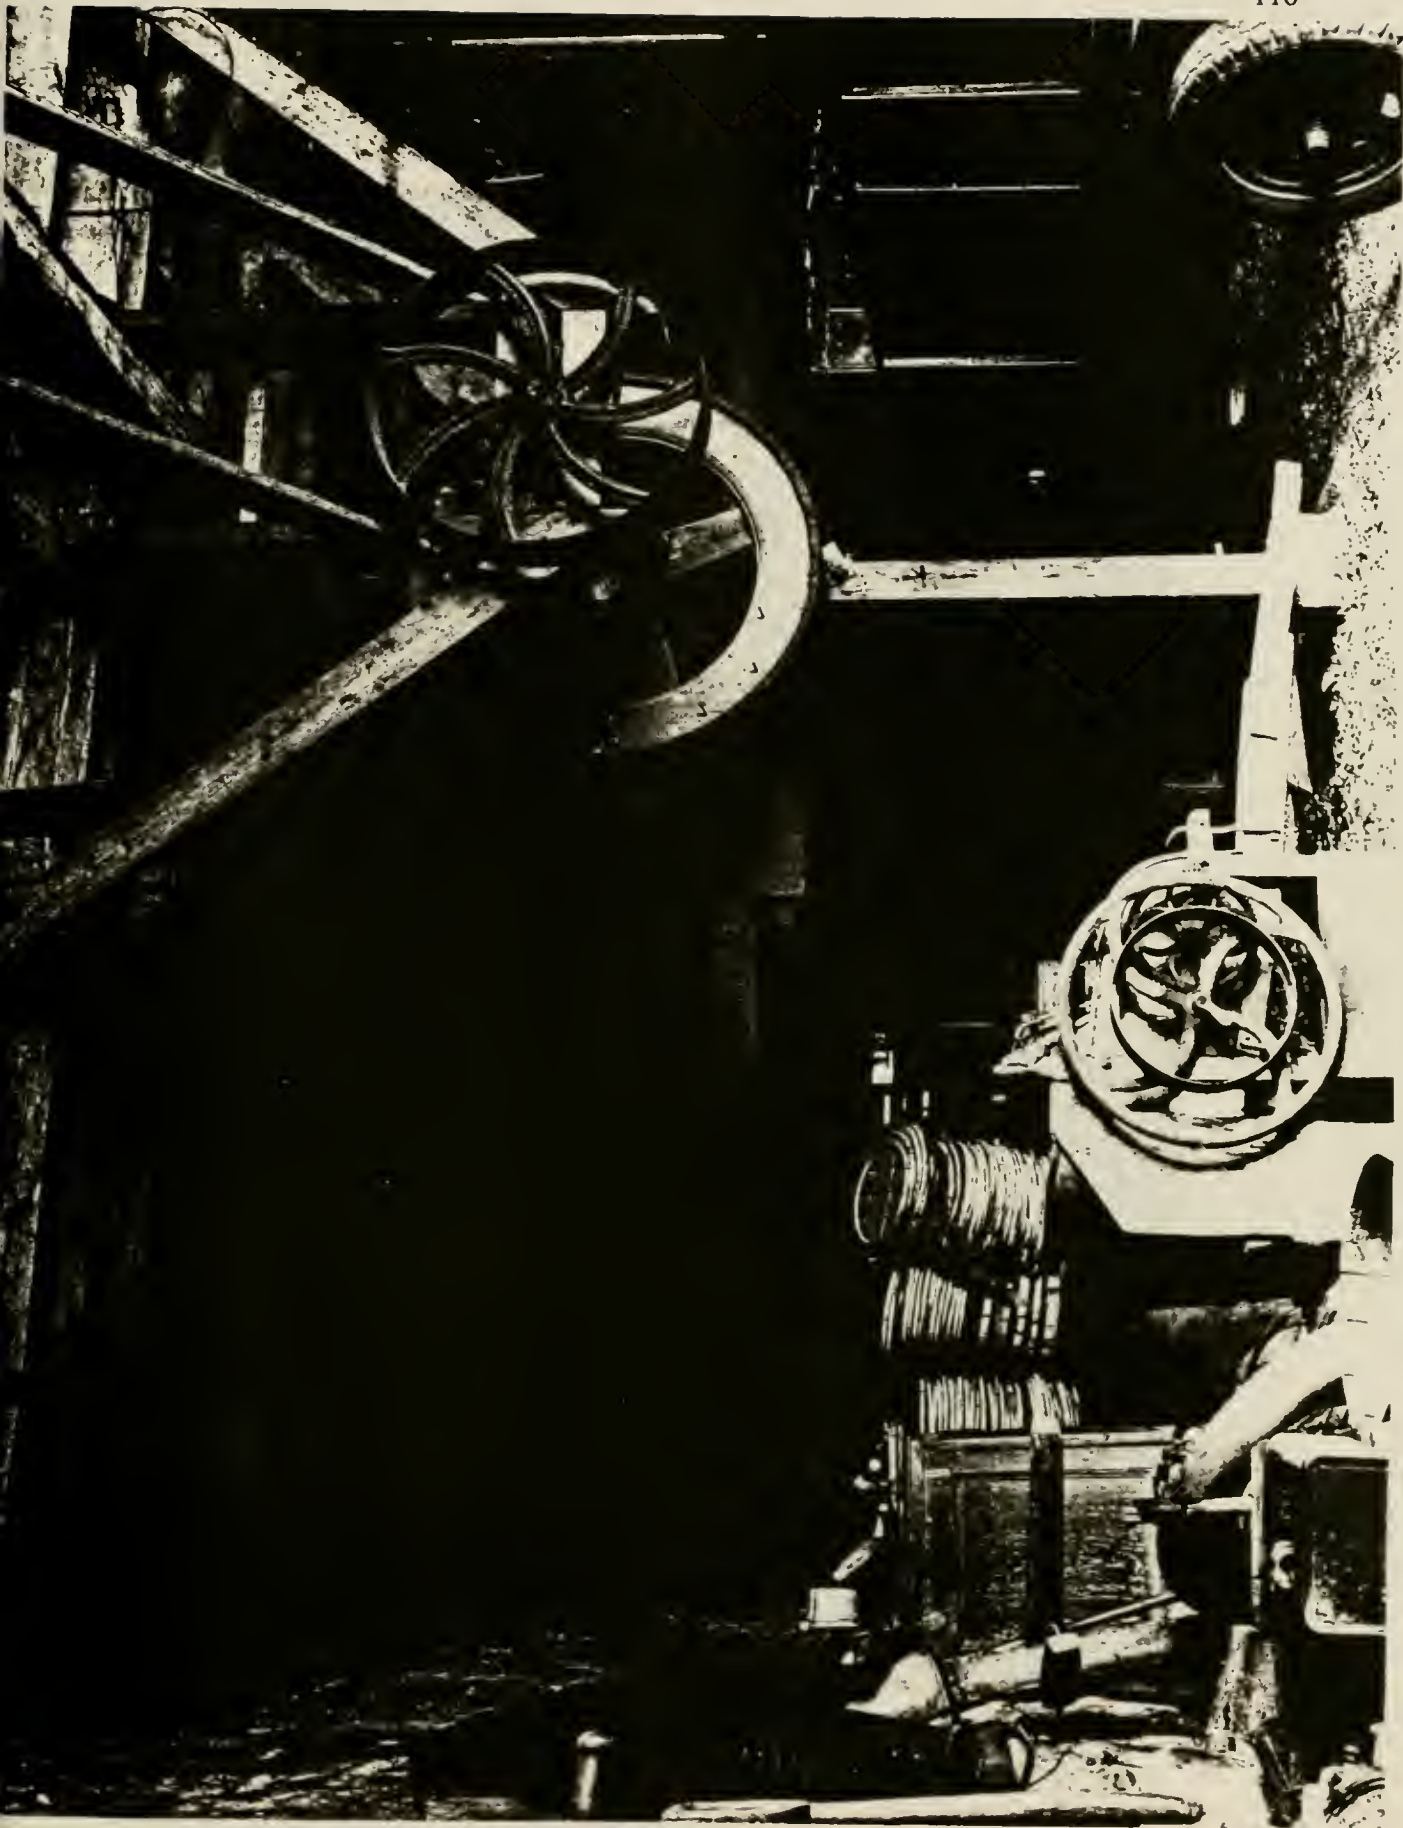
Plate 57: 1845 carriageway looking east, showing machinery setup, taken in 1940s. H.A.B.S. #PA-5350-4 (Washington, D.C.: Library of Congress)

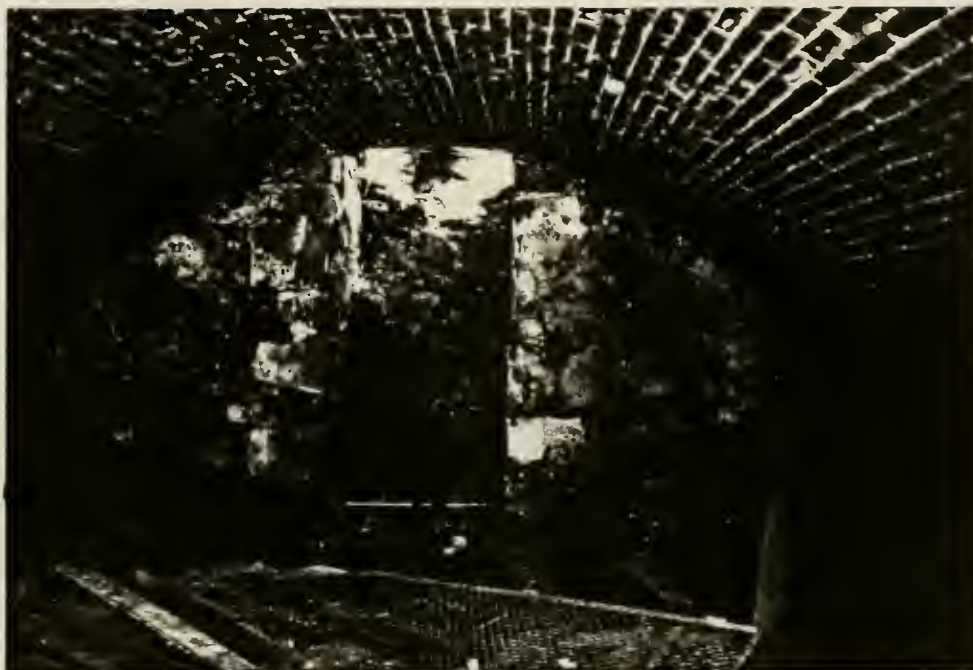
Plate 58: Brick vault #3, which runs in north-south orientation. View north towards shaft opening.

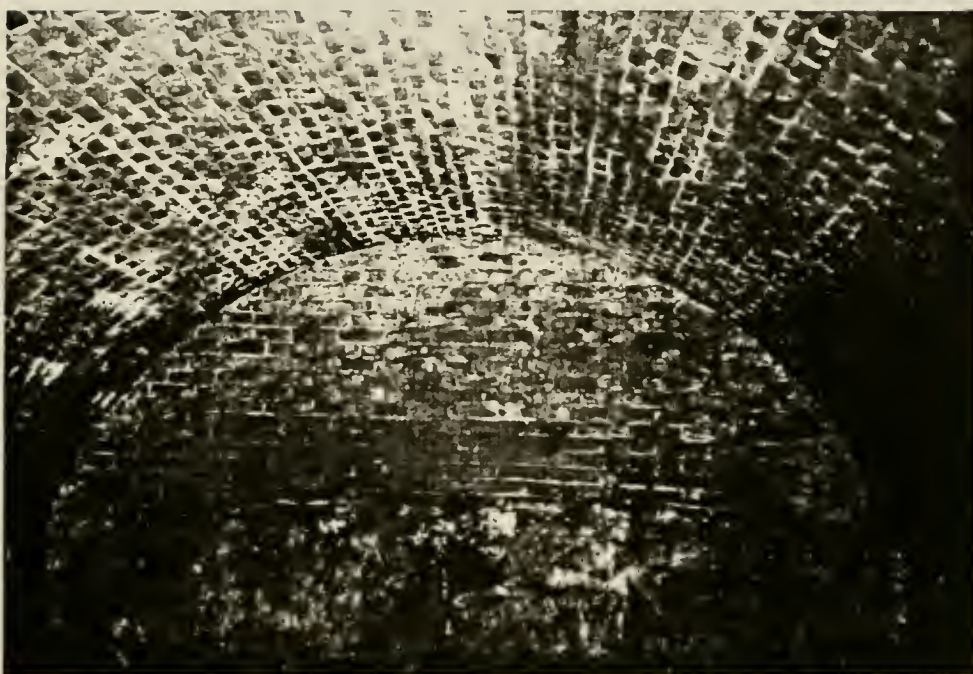
Plate 59: Brick vault #4 (north-south orientation) looking towards north end wall. Arched vault slopes downwards to north.

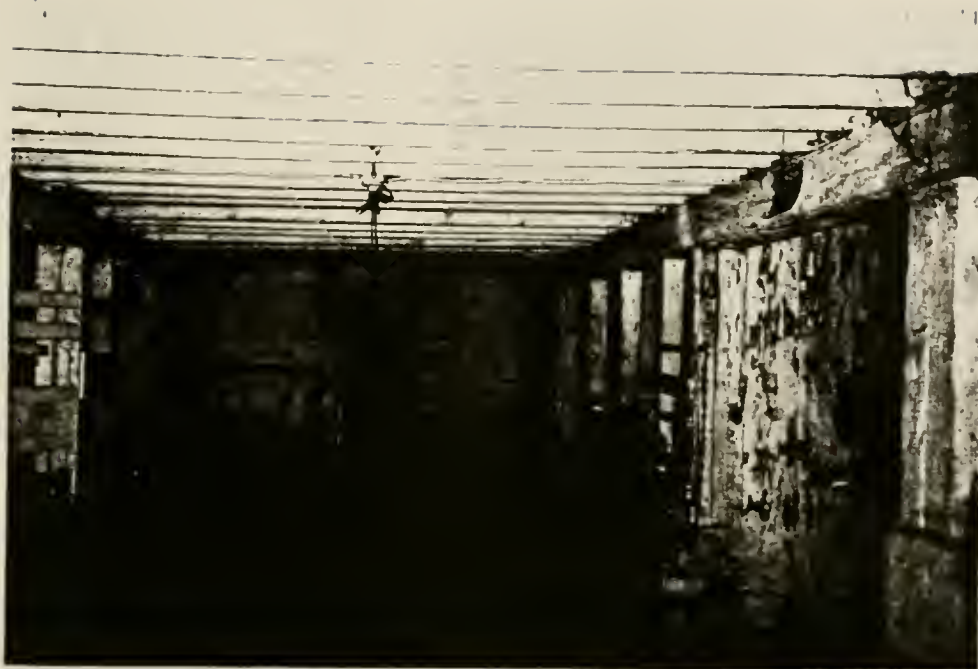
Plate 61: 1845 stall section, looking east towards original west gable end door. Arrangement consists of center aisle and stalls along north, south, and west walls.

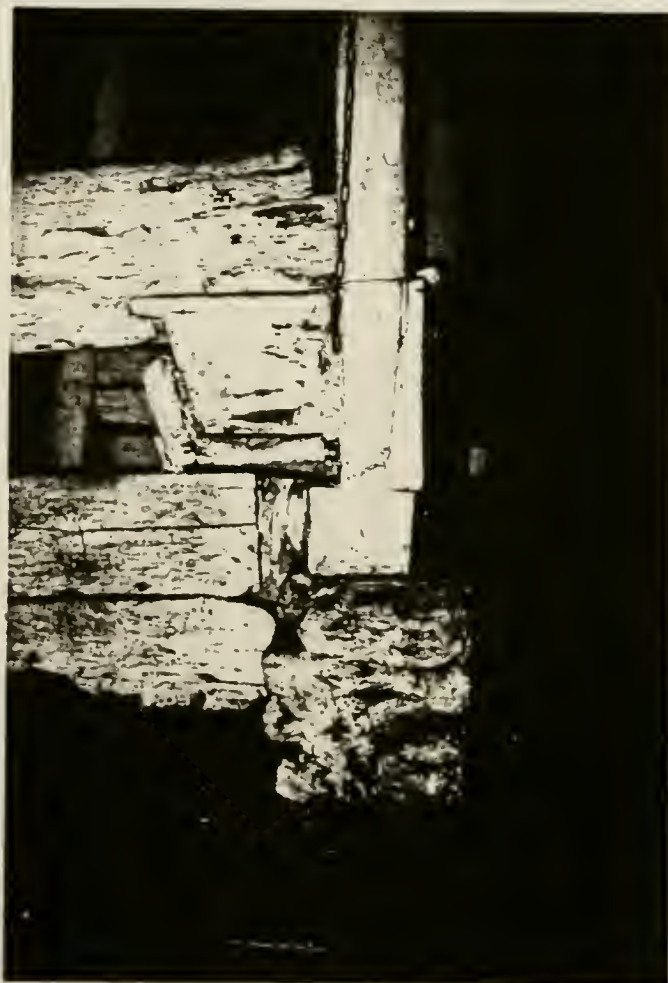
Plate 62: South stall area in 1845 section, showing broken stone foundation wall at midsection

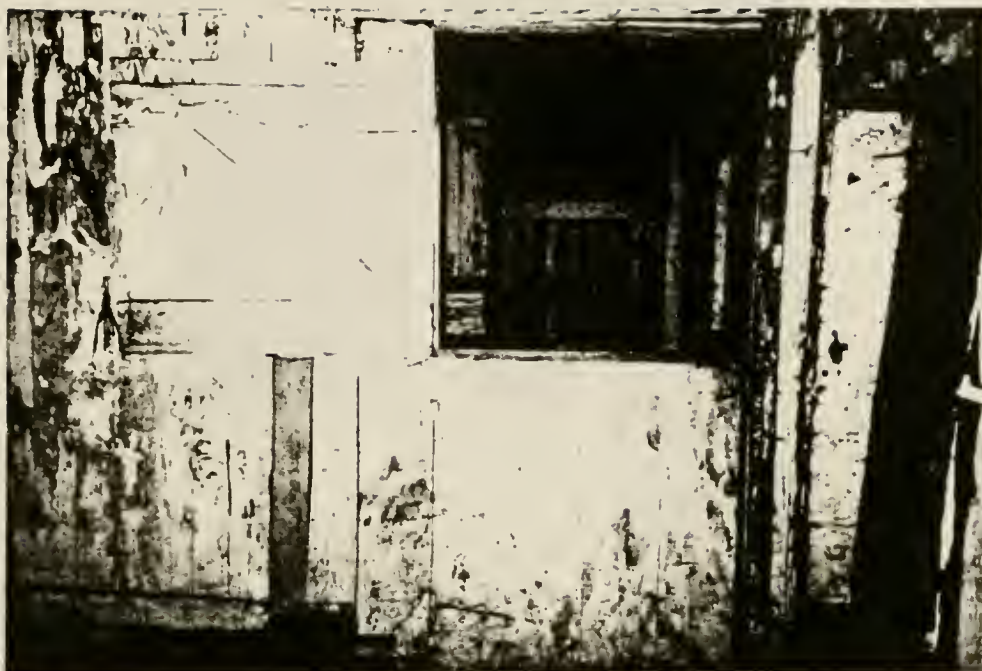
Plate 63: Close-up of half-opening into enclosed stalls along southeast section of 1845 stable area

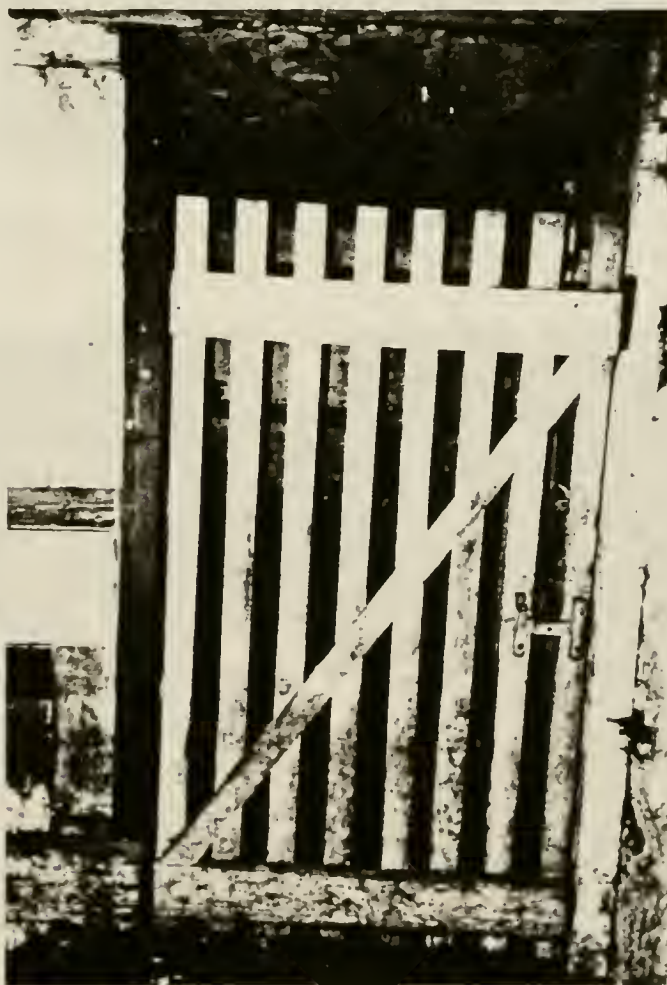
Plate 64: Close-up of vertical slatted door into second stall along southeast section of 1845 stables

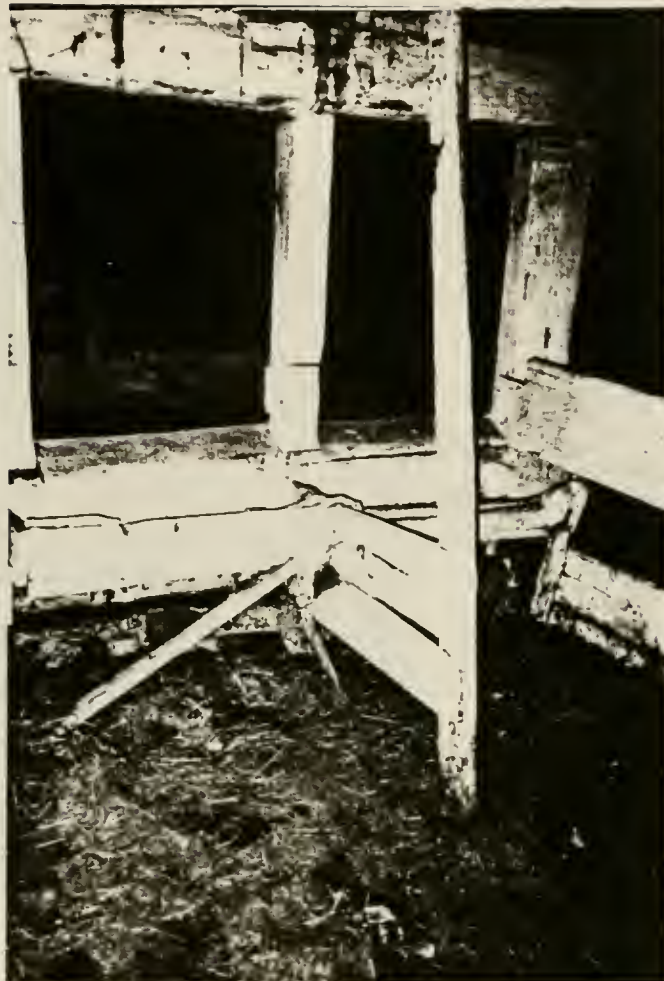
Plate 65: View of open stalls along southwest section of 1845 stables. Note built-in trough and sloping ground level.

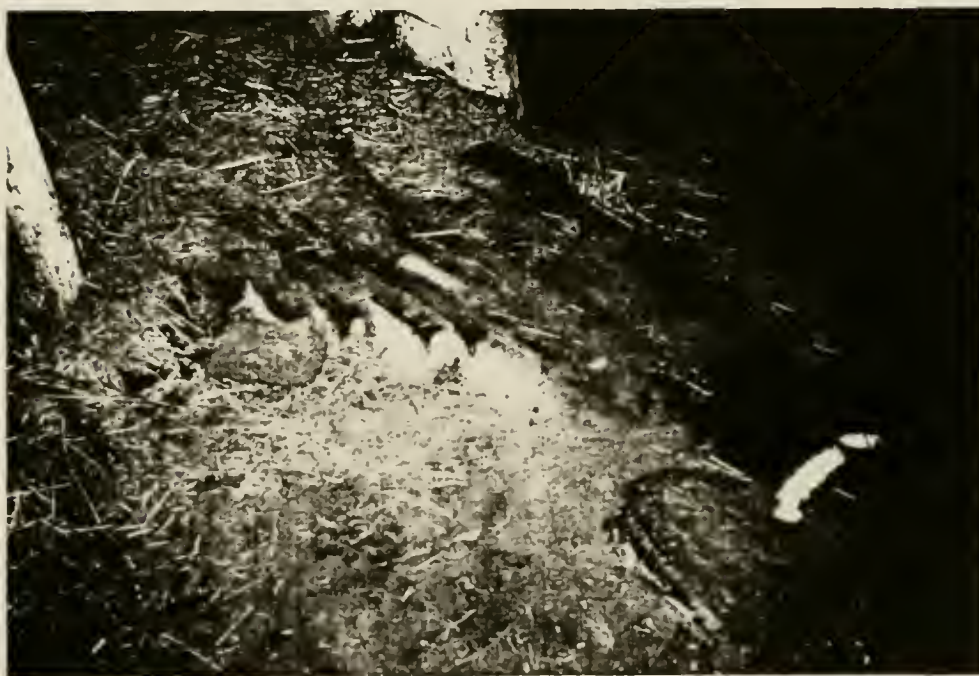
Plate 66: Detail of sloping brick paving in southwest stall section uncovered during archaeologist's investigations

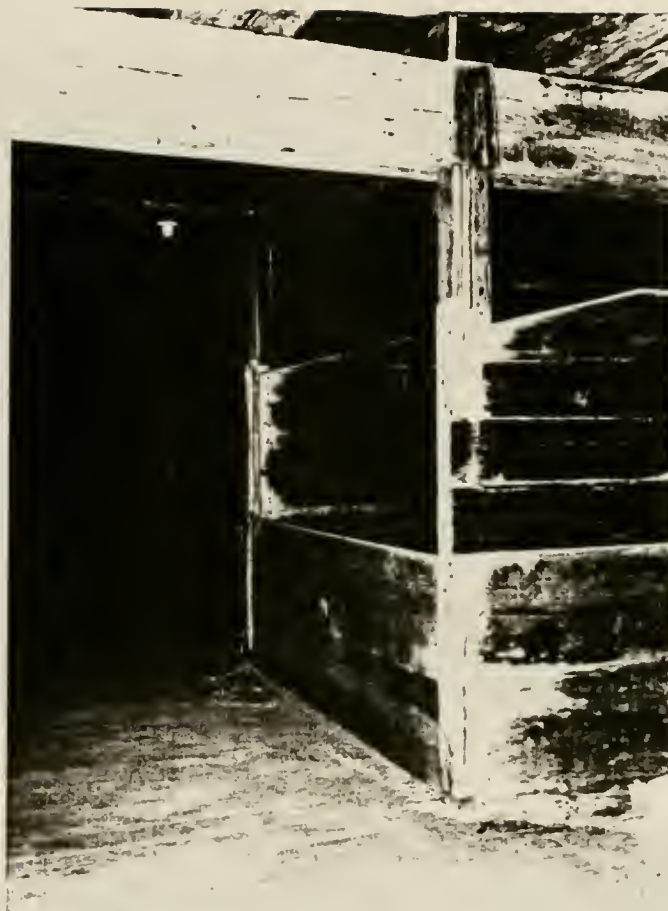
Plate 67: Middle level of 1845 section, showing grain bins with sliding horizontal boards running along tracks on sides

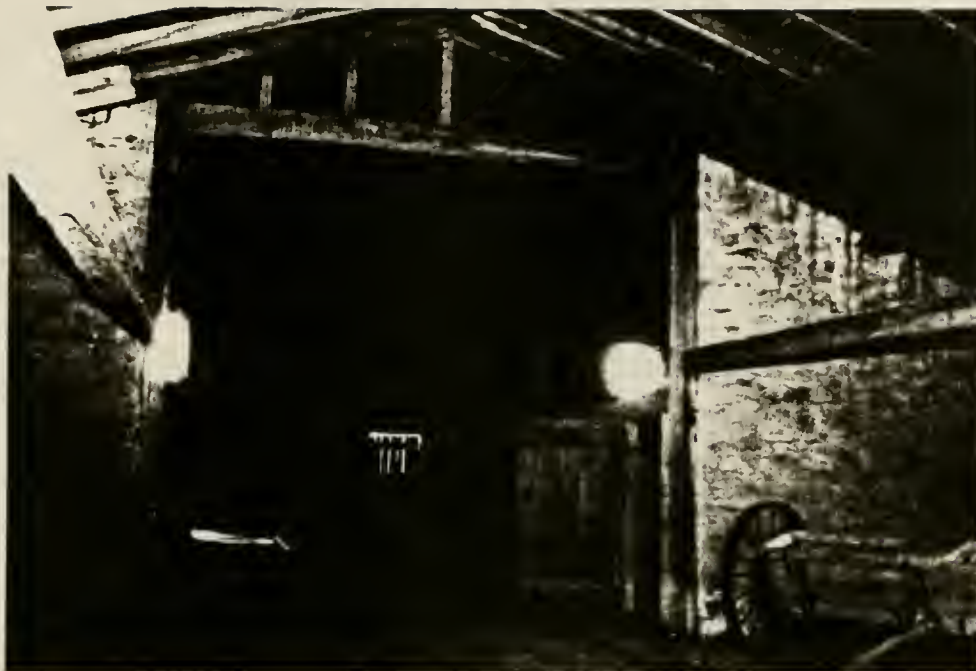
Plate 69: Threshing floor level of 1845 section , looking towards south elevation. Shed section and barn bridge in foreground.

mow. A loft was built above it, creating a 7- foot high enclosed space. Ladders are integrated into the vertical framing which make it possible to retrieve hay when the mows are well-stocked. Two doors were placed along the south elevation, one near the platform section and one at the end of the threshing platform (Plate 75). A 13 foot wide opening was centered along the north stone wall, providing enough width for wagons to turn enter the platform and turn around after unloading (Plate 69).

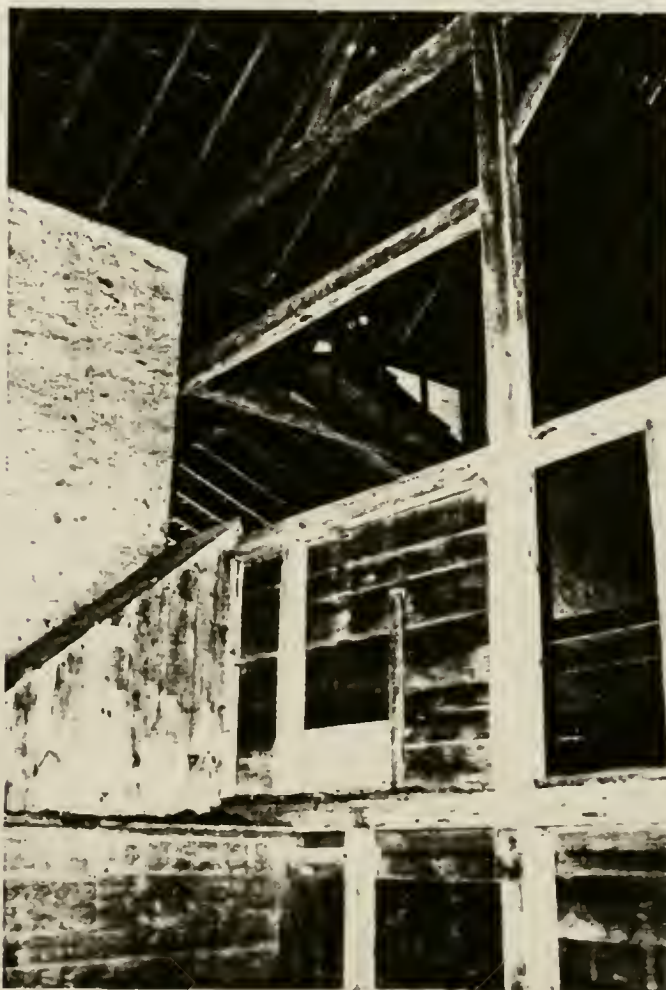
Plate 70: West hay mow of 1845 section, looking northeast, showing enclosed staircase on north wall

The middle level of the 1845 barn section consists of a similar three-bay composition as the 1826 middle level (Fig. 16). The center portion serves as grain storage, having a ceiling height of approximately 7 feet, and the two side aisles function as the floor to the hay-mows. The granary section measures approximately 14 feet across and consists of three storage bins placed along the east partition. A hay chute and ladder were located on the other side of this partition, providing a convenient arrangement between distribution and storage--grain was dropped down shoots and delivered to the bins. These bins, measuring between 6 to 8 feet in width and 8 feet in depth, employed wood boards on sliding tracks to hold the various grains, such as oats and barley (Plate 67). The hay-mow along the east side was partially enclosed, creating an area 12 feet 6 inches wide by 17 feet long. A door along the south end of the west partition opened into a large hay chute, which extended to the threshing floor. The staircase along the northwest wall continued up to the third floor threshing platform (Plate 70).

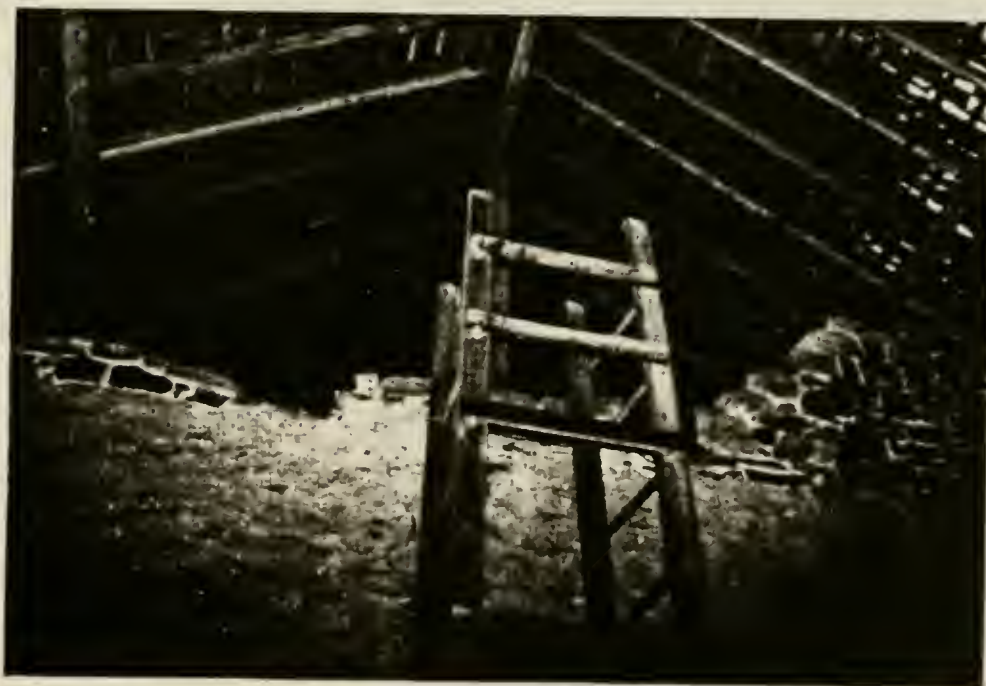
Plate 72: Close-up of ventilator poles. Note broken section of original west gable end

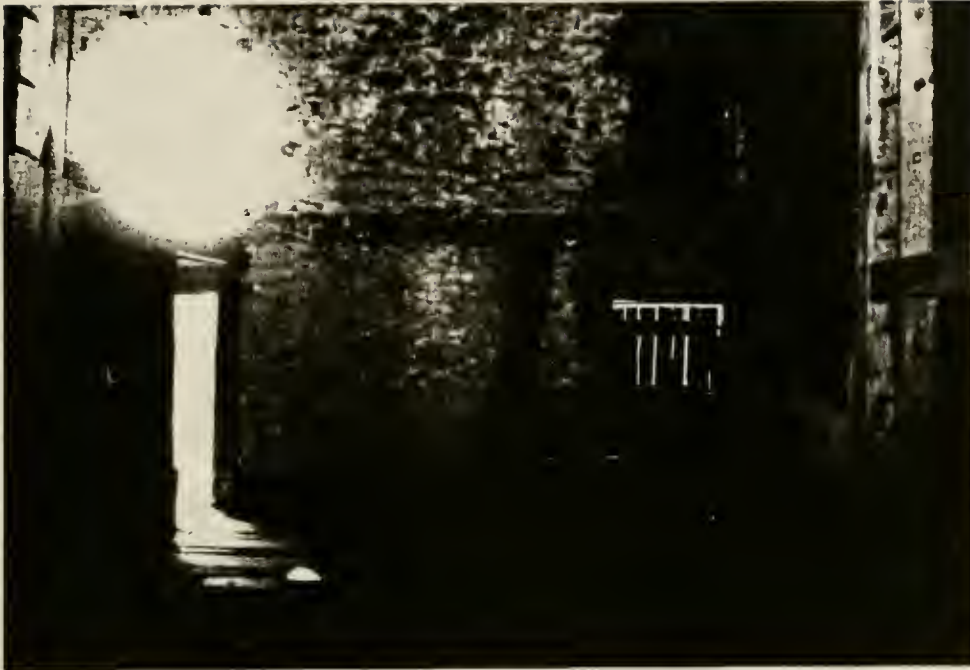
Plate 75: 1845 threshing floor, looking south, showing impression in stonework across platform section of south elevation. Possibly location of loft space (similar to 1826 section). Note loft space to left, located above east hay mow.

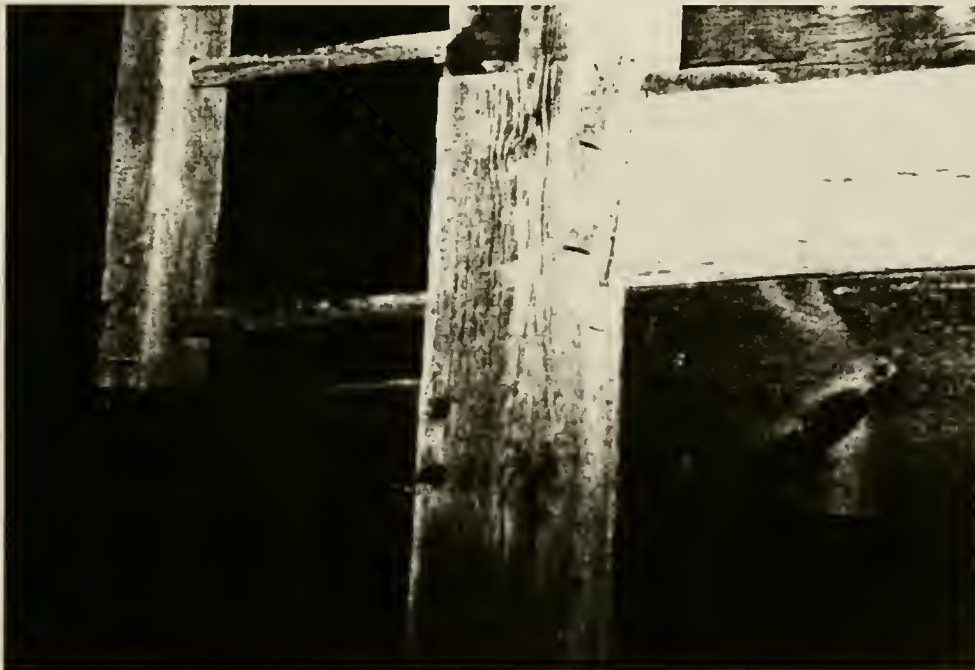
Plate 76: East side bent of 1845 threshing floor, showing detail of mortise-and-tenon joinery and numbering system on pieces.

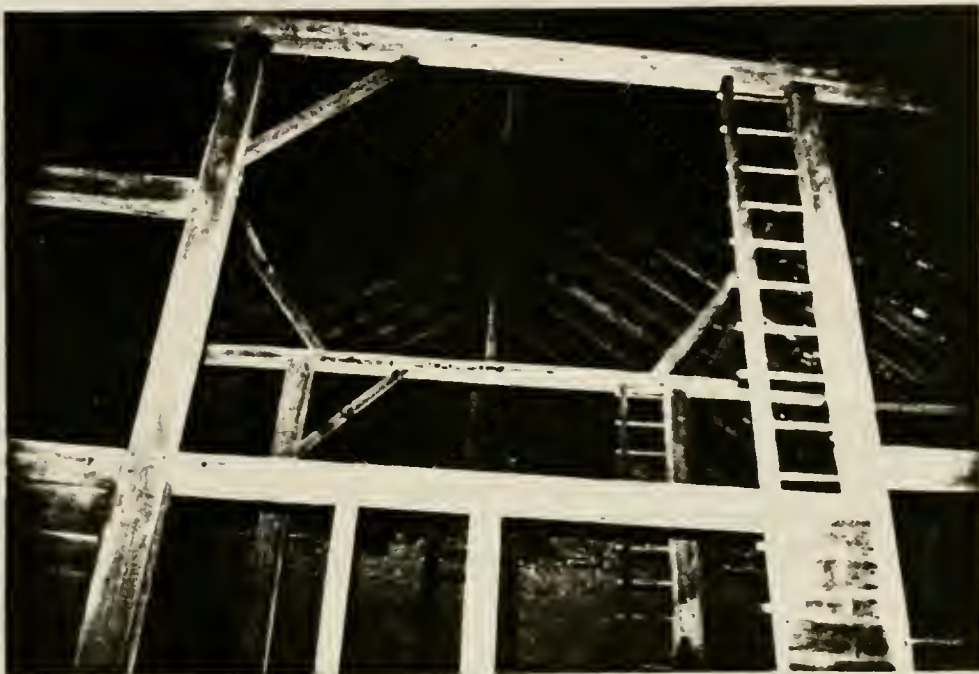
Plate 77: 1845 threshing floor, showing both bents located on sides of platform with view to original west gable wall. Note shingled underside of roof.

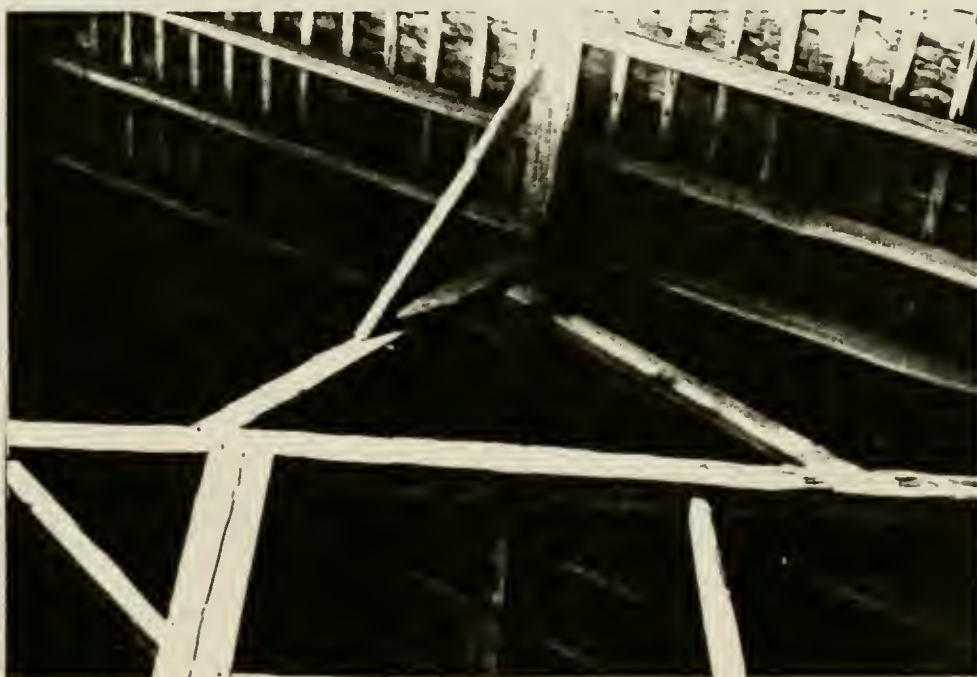
Plate 78: Detail of diagonal braces at roof level of 1845 barn

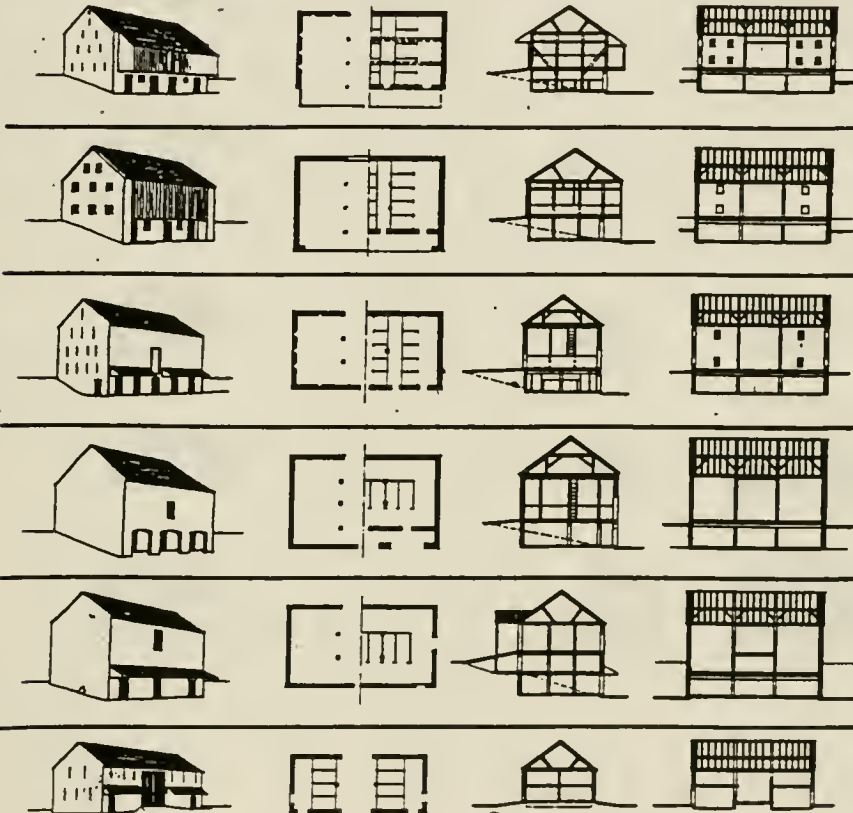
TYPE A. Barn or "barnhouse" type. Cantilevered porch projects over stable wall. Three or three sides. Good for hay on fourth side. Main slope continuous over porch. Hay mow usually three or more bays in length. Stables at lower level entered from front. Width of barn generally two or three bays. Cantilever supported on masonry wall. Type common in Lancaster County and Berks.
